Floodplain Management Study

Milton Creek Columbia County, Oregon

Technical Appendix

MILTON CREEK FLOODPLAIN MANGEMENT STUDY
TECHNICAL APPENDIX

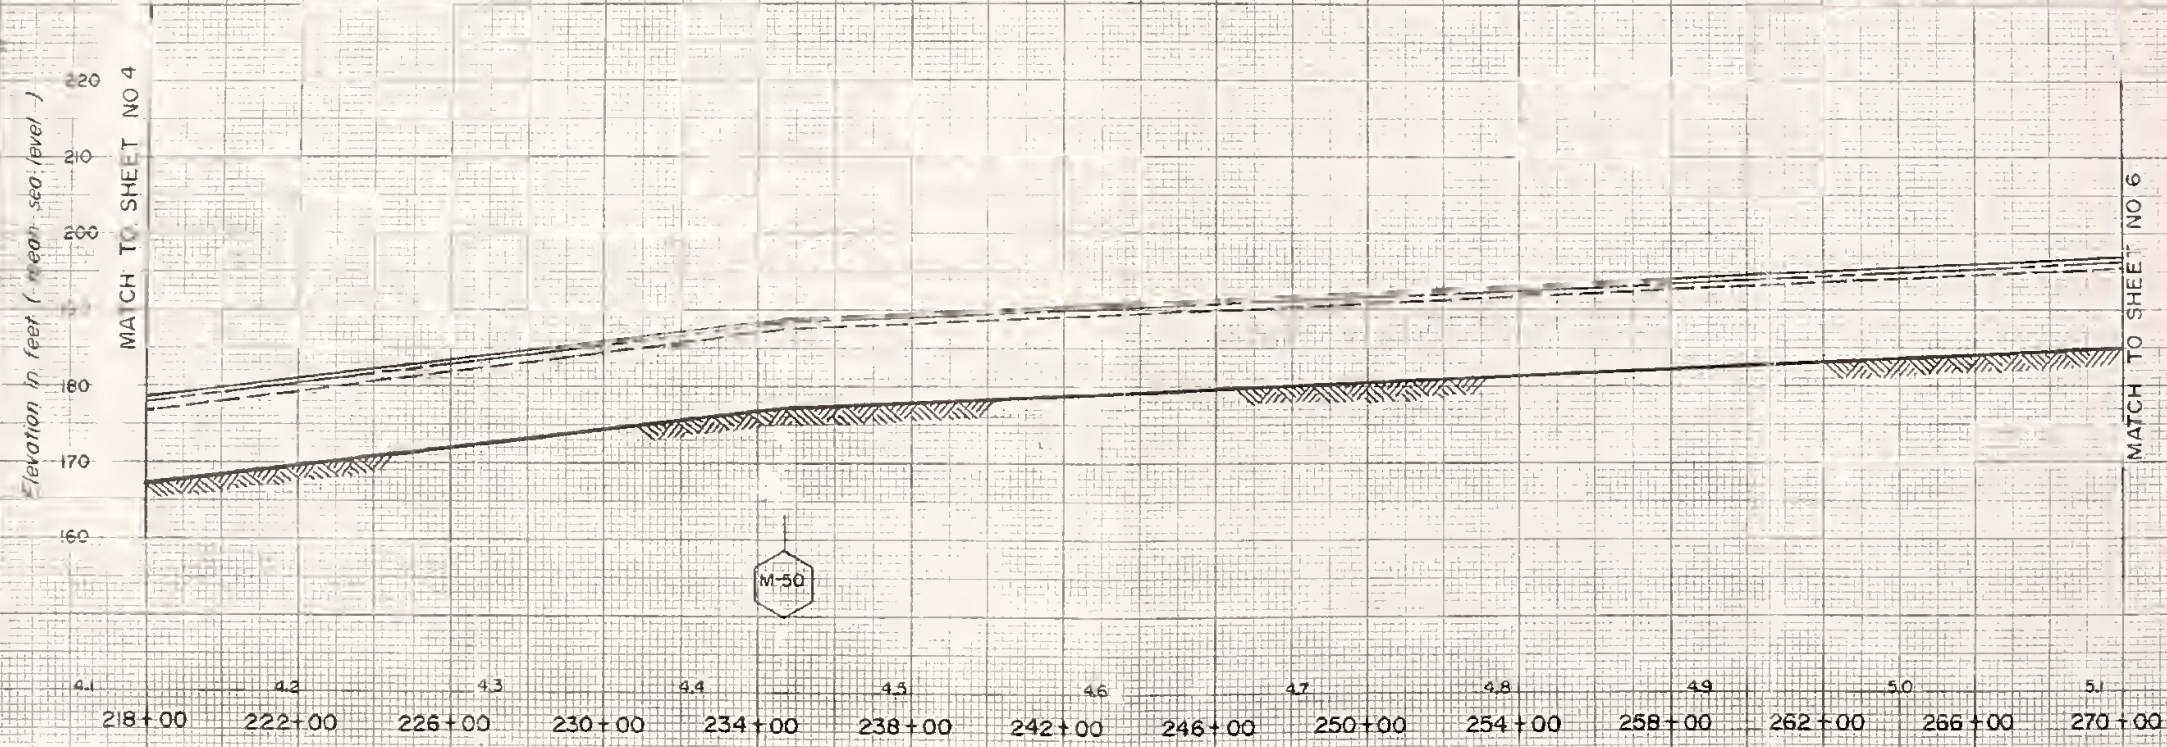
Attachment 3 sheet 5 of 8

PROFILE

FLOODPLAIN MANAGEMENT STUDY

Flood profiles are presented in Attachment 3. The profiles show the river bottom, and the 10-, 100-, and 500-year flood elevations. Cross-section locations and their stationing are shown. The river mile index is also shown on the profiles. The profile will give an indication of the depth of flooding at the deepest point on each surveyed cross-section and the slope of the flow lines. The bridges in the study are located on the profiles.

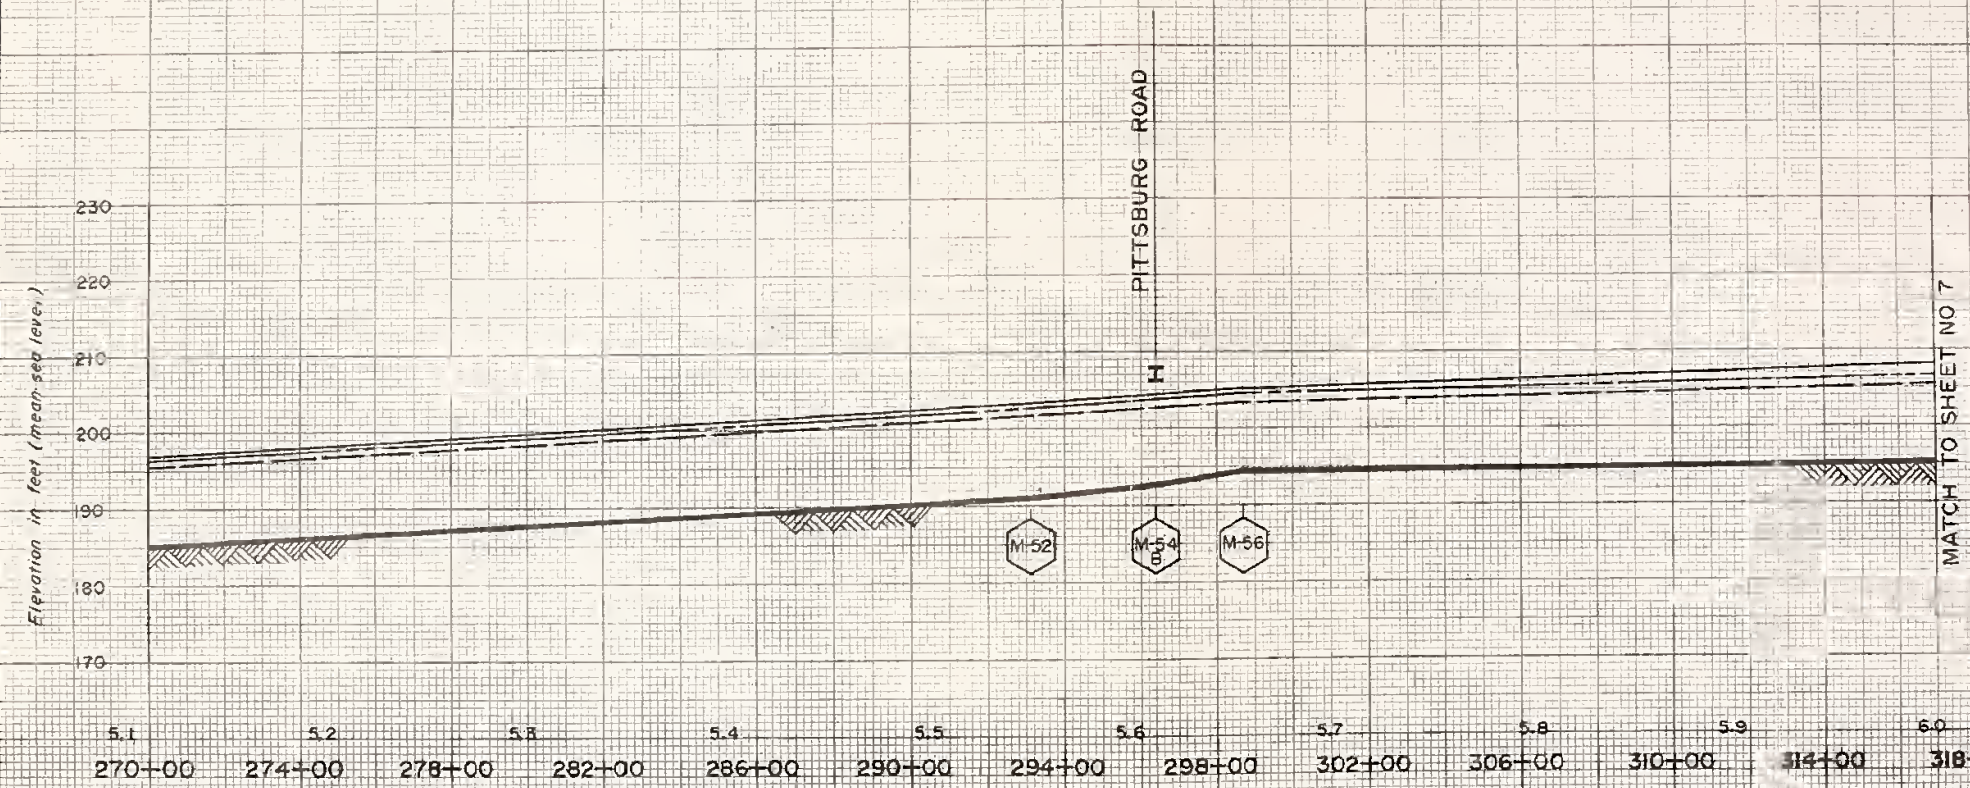
Attachment 3 sheet 6 of 8

PROFILE

FLOODPLAIN MANAGEMENT STUDY

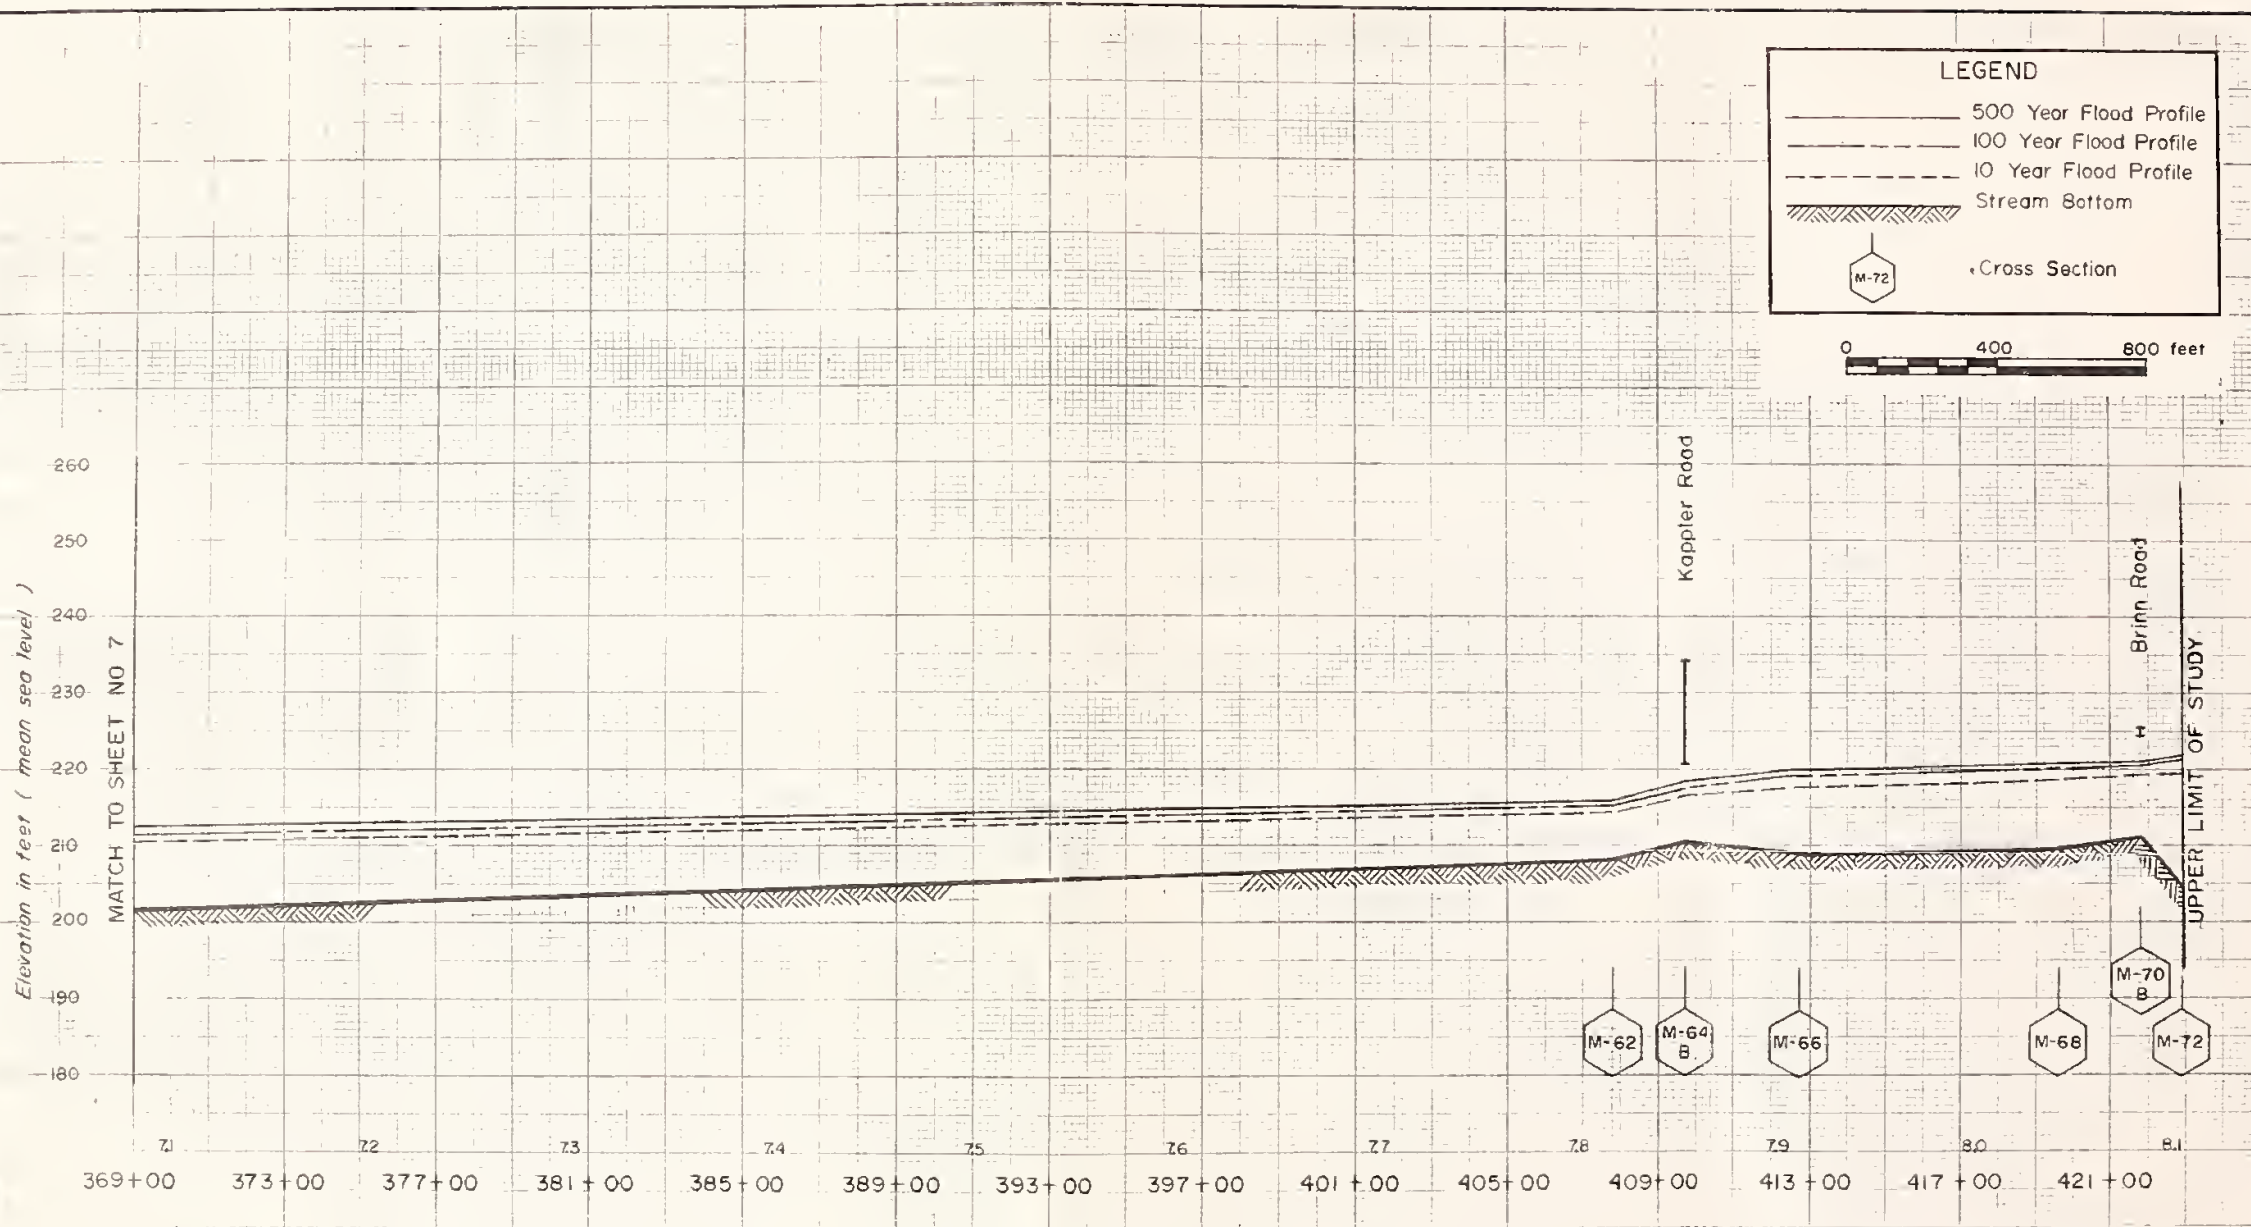
Attachment 3 sheet 8 of 8

PROFILE

FLOODPLAIN MANAGEMENT STUDY
MILTON CREEK
